Space Shuttle Lessons Learned Knowledge Sharing Forum

NASA KSC Lesson Learn Entry: 3236 Solid Rocket Booster (SRB) Flame Trench Refractory Failure Modes

**Gabor Tanacs
Armand Gosselin
USA L&RS Engineering
January 27, 2011**

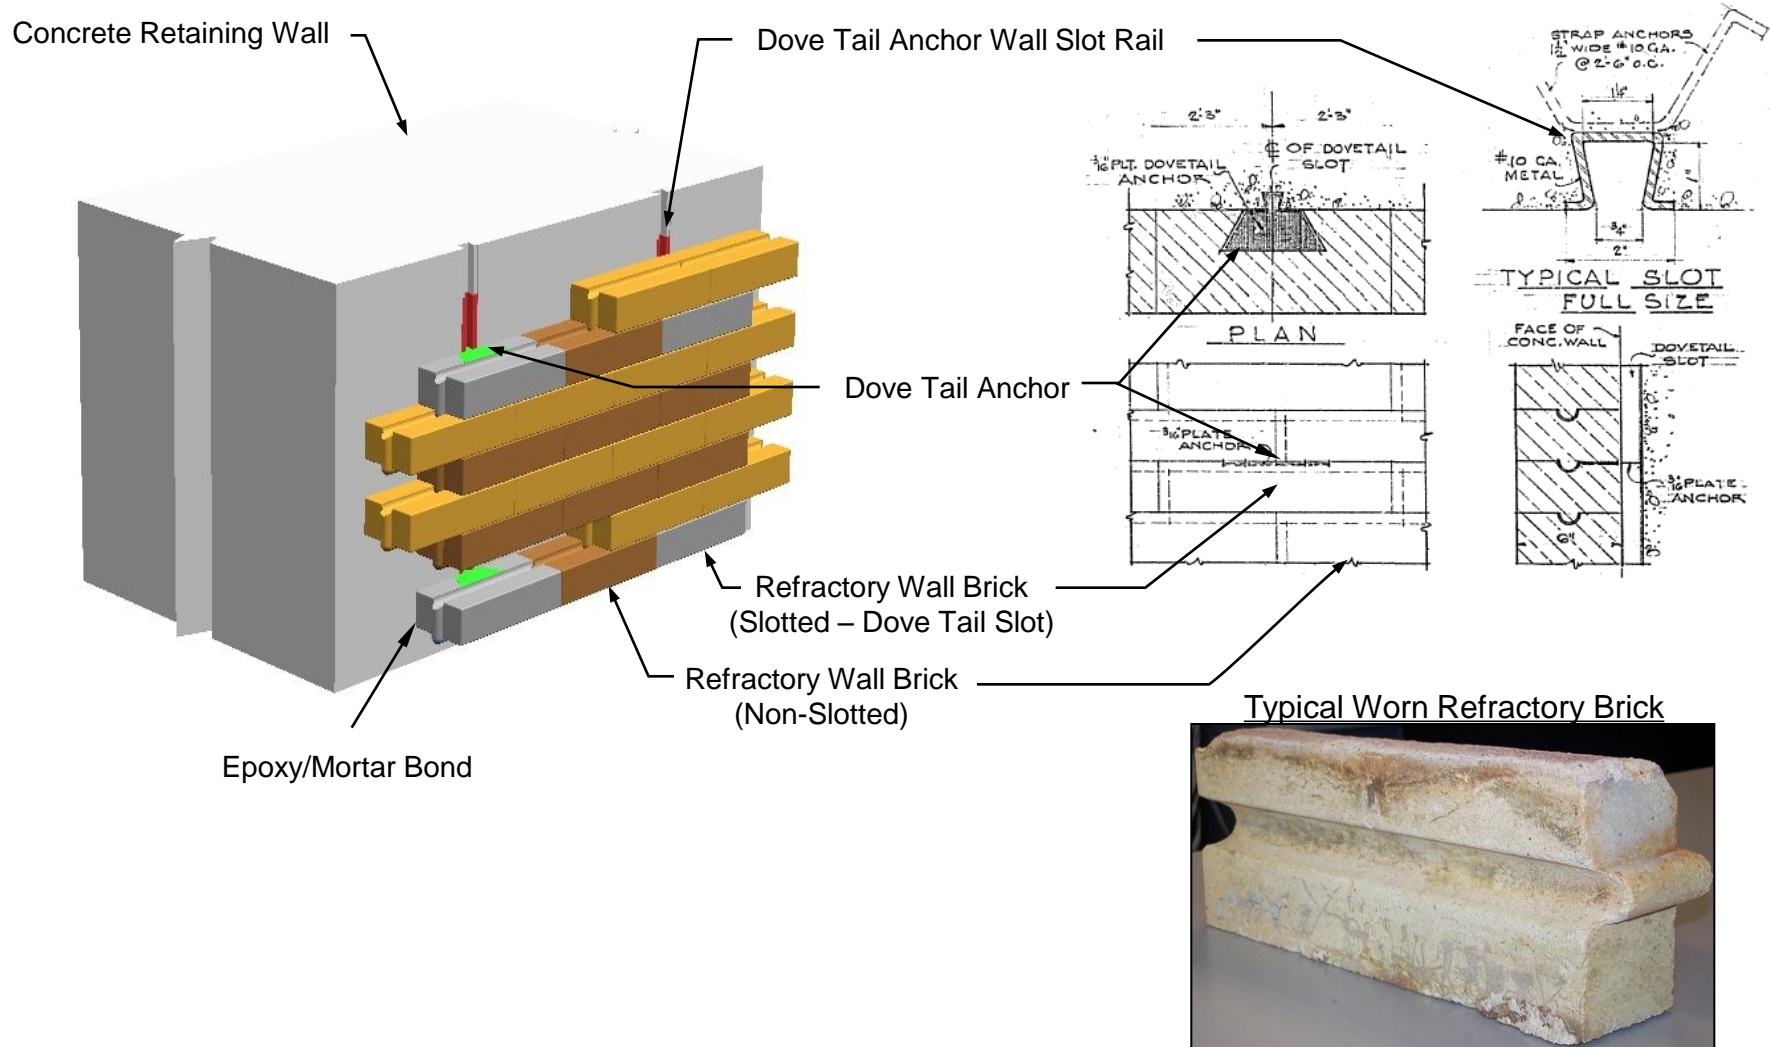
Flame Trench East Wall Damaged Area

- East Brick Wall Damage
 - Estimated Total Bricks On East Wall ~ 22,000
 - Estimated Lost Bricks ~ 3,540 (16% Loss of East Wall)
